**ADVANCED COMPOSITE ELEVATOR
FOR
BOEING 727 AIRCRAFT**

**FIFTH QUARTERLY TECHNICAL PROGRESS REPORT
23 MAY 1978 THROUGH 22 AUGUST 1978**

**PREPARED FOR:
NATIONAL AERONAUTICS AND SPACE ADMINISTRATION
LANGLEY RESEARCH CENTER
HAMPTON, VIRGINIA 23665**

**IN RESPONSE TO:
CONTRACT NAS1-14952
DRL LINE ITEM NUMBER 018**

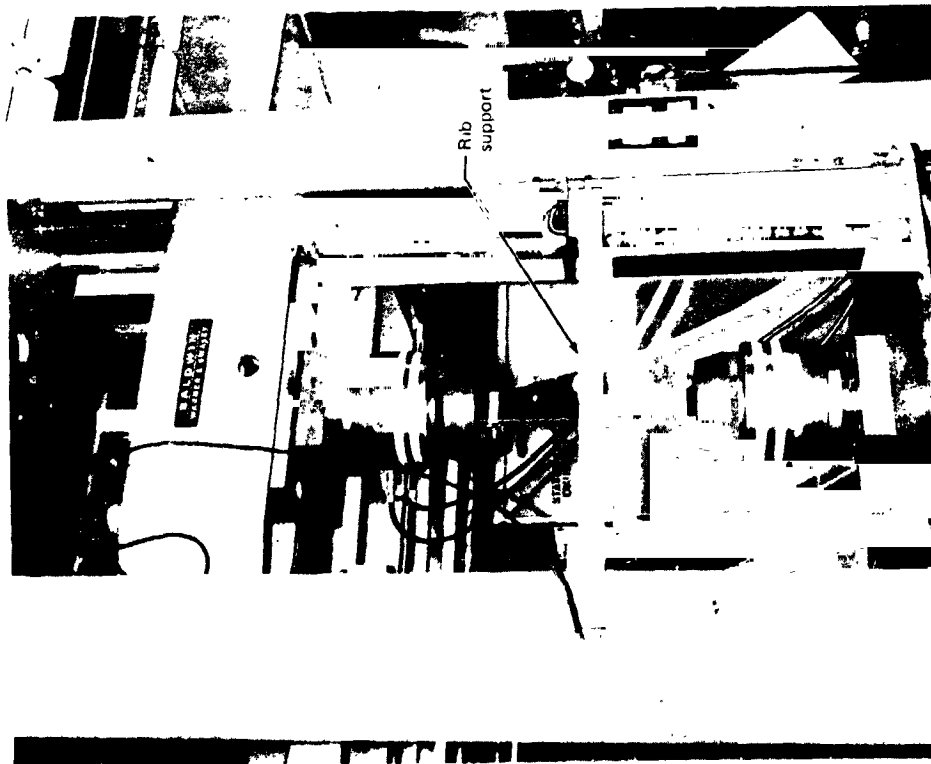
Figure 2-4. Cover Panel Padup at Ribs Static Test

Test No. 8-Panel/Rib Pad-Figure 2-4 shows the test setup for this test. Elevator skin panel support at rib intersections was simulated for this test. Specimens were tension tested to failure, using a hydraulic grip machine setup. Test results are presented in Table 2-7.

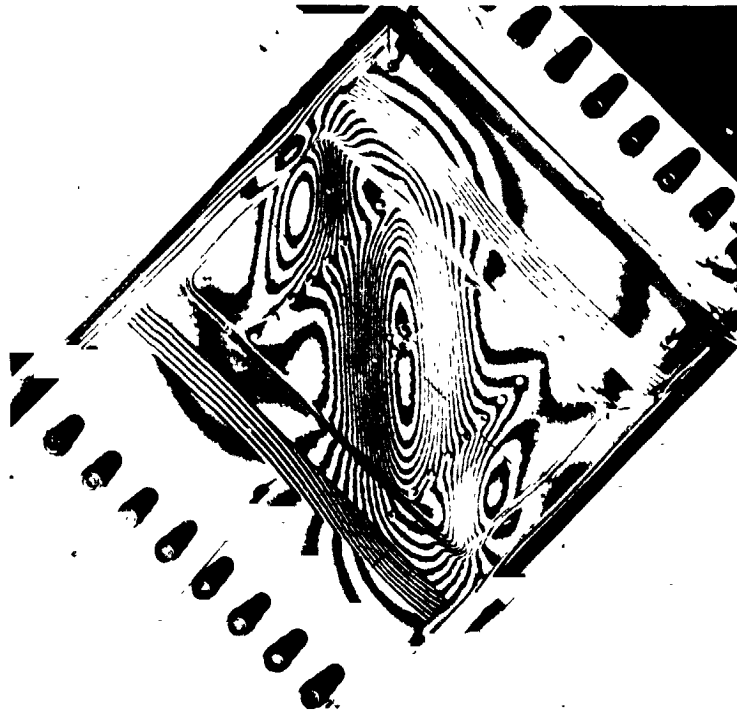
Figure 2-6. Typical Moire Fringe Pattern Prior to Failure

Typical moire fringe patterns, just prior to failure and just after failure, are shown in Figures 2-6 and 2-7.

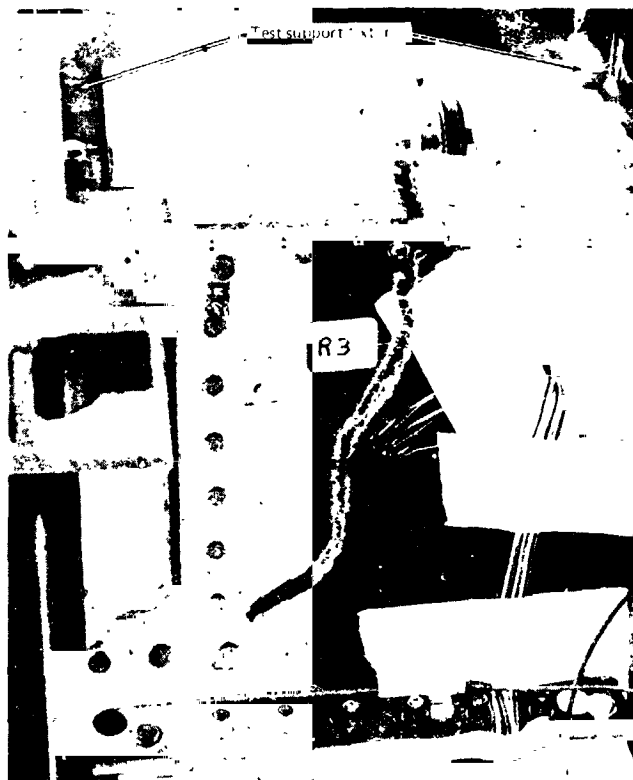
Figure 2-17. Front Spar/Actuator Fitting Splice Test Specimen Failure

Figure 2-18. Front Spar/Actuator Fitting Splice Test Specimen Failure

Figure 2-19. Front Spar/Actuator Fitting Splice Test Specimen Failure

The test specimen failed at approximately 80% of the predicted failure load. Post test analysis, using strain gage data just inboard of the failure, indicated that local splice eccentricity effects were greater than anticipated for the test specimen configuration. Although local lateral straps were used to stabilize the spar chords, the continuous skin support that will exist on the airplane elevator component was not duplicated in this test. The eccentricity effects will be greatly reduced on the full-scale hardware.

At the point of failure, the test load was equivalent to approximately 1.9 times the critical design ultimate load for a flight condition. In the test specimen spar constant section, the load at failure was equivalent to approximately 1.4 times the critical design ultimate load for a flight condition.

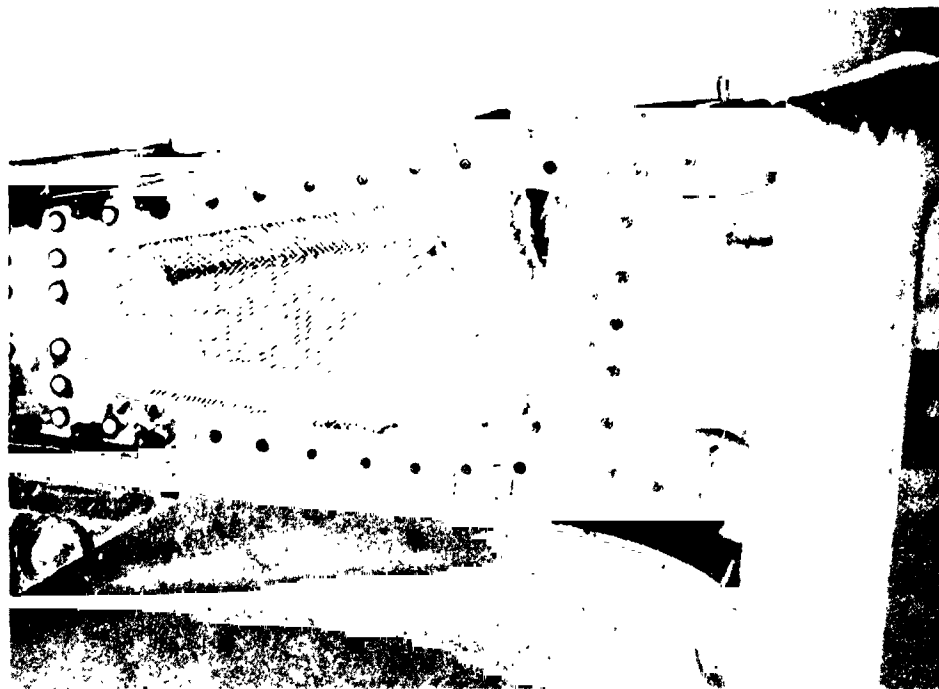
Figure 2-23. Actuator Support Rib Failure

Figure 2-24. Actuator Support Rib Failure

The test specimen failed at approximately 1.06 times the predicted failure load. The test failure load was equivalent to approximately 3.5

times the actuator capacity on the airplane component. The graphite/epoxy rib was sized to achieve approximately the same stiffness and strength as the current metal design, which was designed to approximately 3.0 times the airplane actuator capacity.

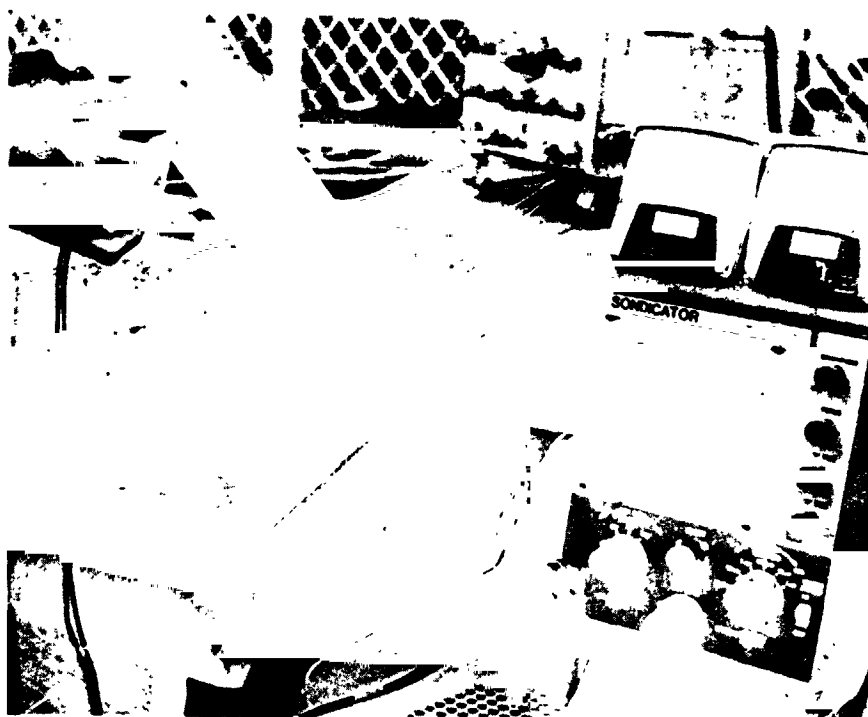
Figure 3-23. Sondicator Inspection of Configuration not Suitable for TTU Scan

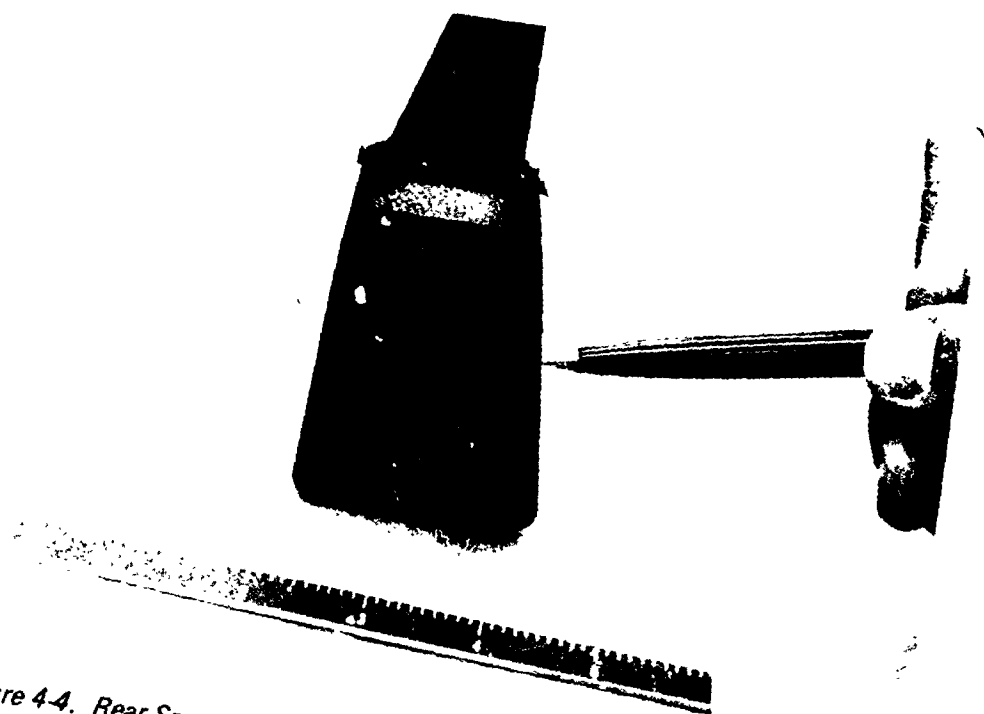
Figure 4-4. Rear Spar with -5 Rear Spar Header Installed, Showing Mismatch

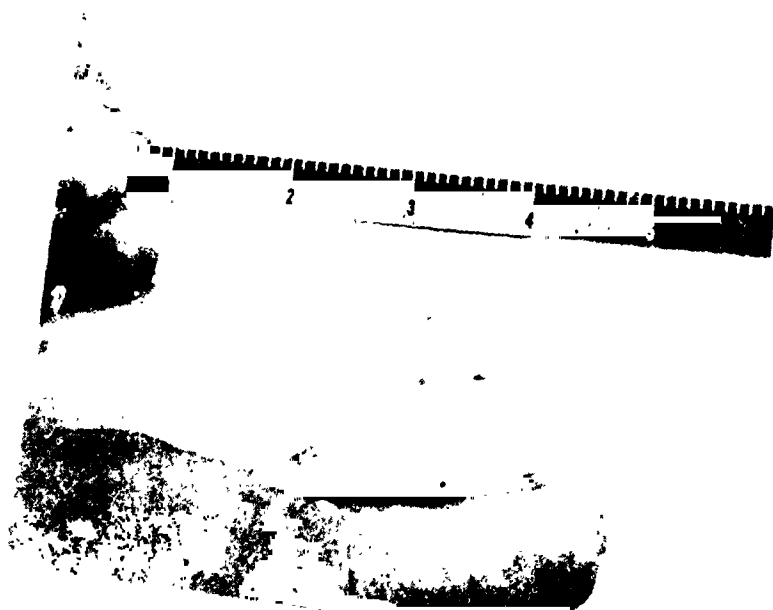
Figure 4-5. Rear Spar Header, Showing Bow in Side

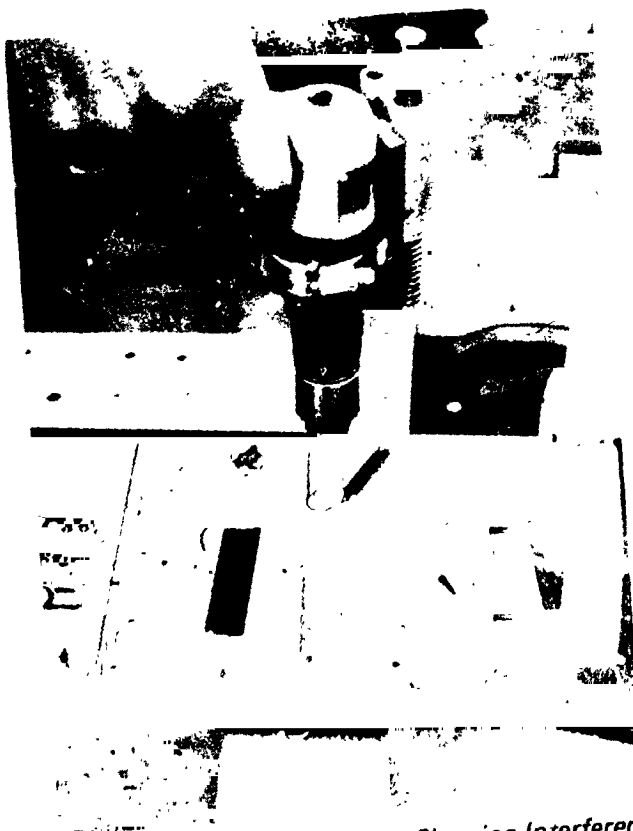
Figure 4-9. Drilling Attach Angles on Front Spar, Showing Interference Between Angle and Vacuum Collar
